Wetland Delineation

Runway Abandonment Project Runways 1R-19L & 13-31 Milwaukee General Mitchell International Airport (MKE) Milwaukee County, WI

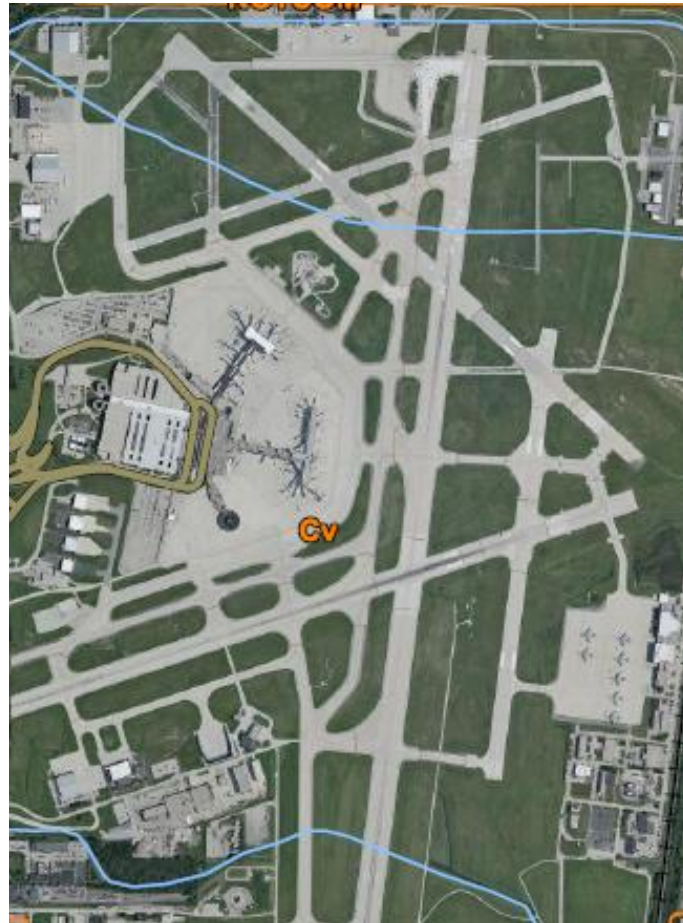
Figure 4.1-1

A review of the NRCS Web Soil Survey mapping revealed only one soil type as being present within the Area of Review (**Figure 4.1-1**).

Cv – Clayey land

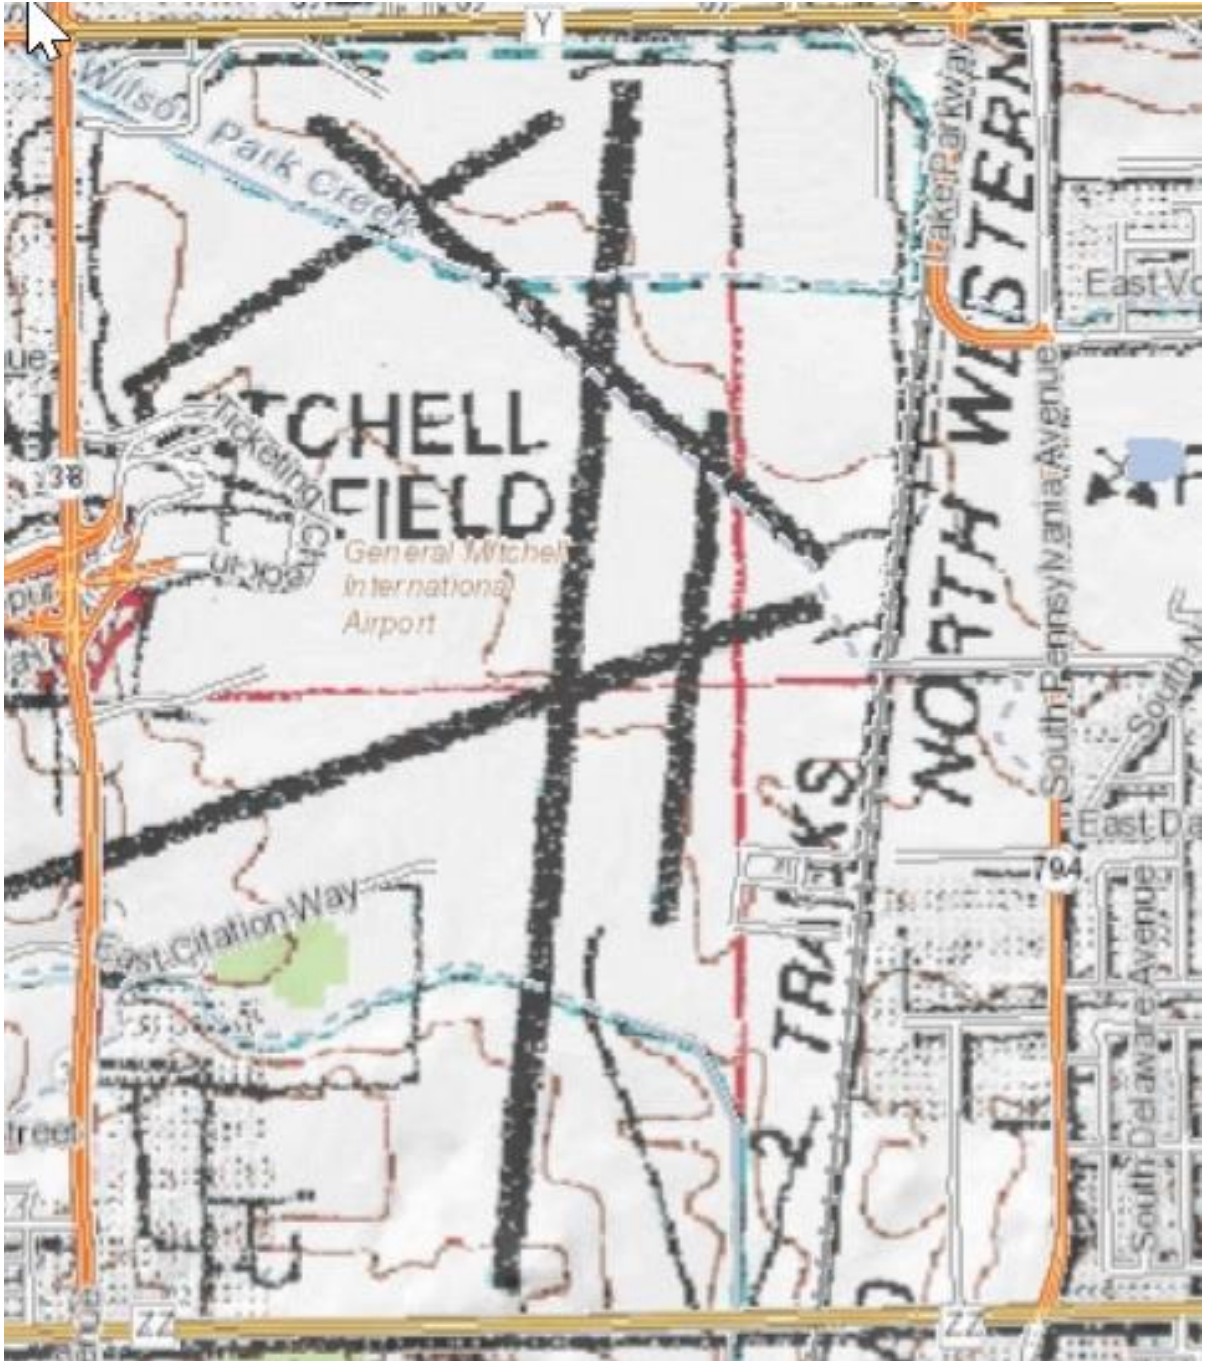
Figure 4.4-1

The topography of the site is very flat. (Figure 4.4-1).

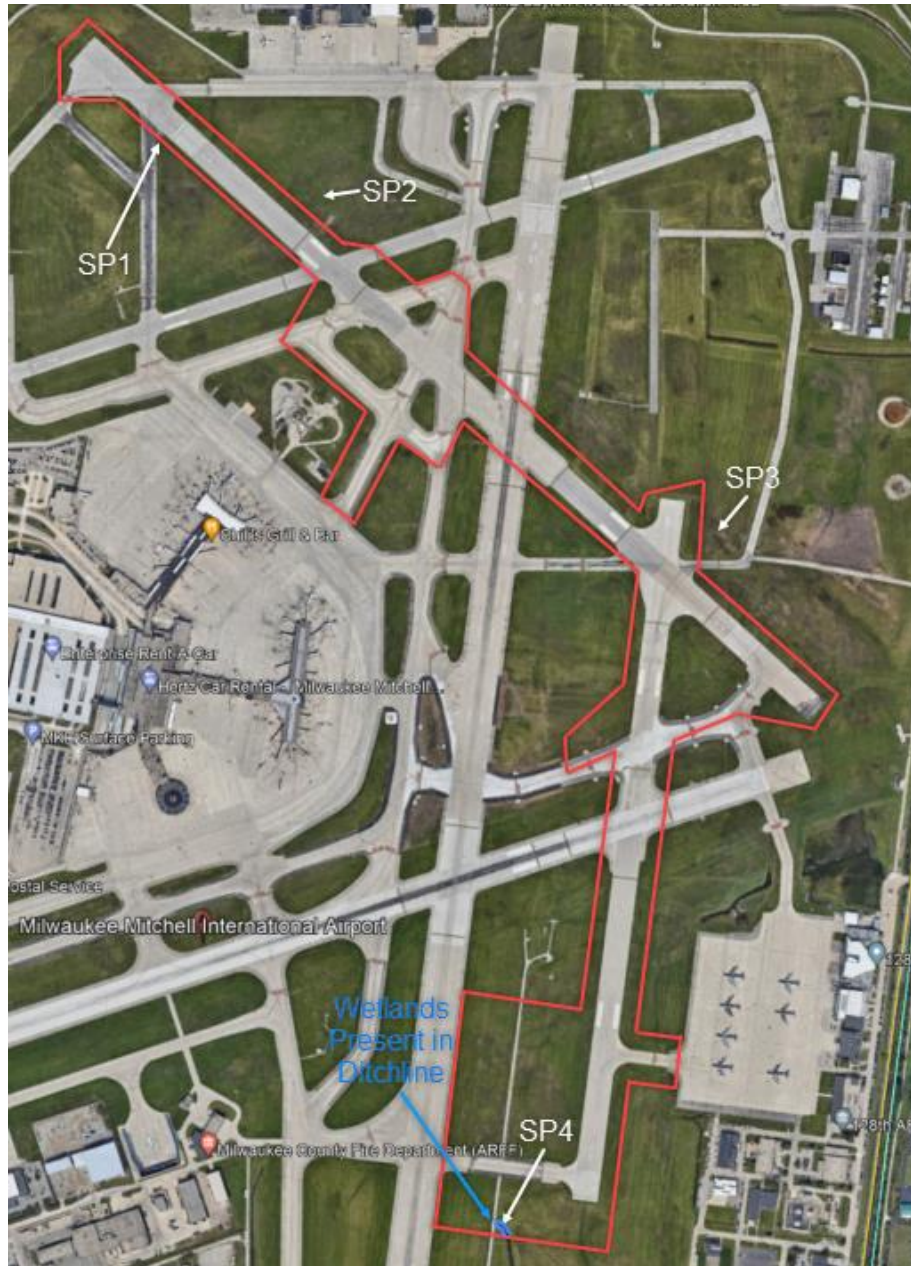
Figure 6.3-1

Sample Plot 4 represents the wetland boundary associated with a ditchline on the south end of the Area of Review for Runway 1R-19L. Due to rain falling prior to and during the field review, the water level within the ditchline appeared to be higher than normal. Due to standing water conditions, no wetland soils investigation was conducted. A soils pit was assessed on the upland side of the wetland boundary. The wetland boundary at this location was distinct, follows the contour of the ditchline and extends southerly beyond the Area of Review.

This delineation determined the presence of just one wetland area within the Area of Review. This wetland is located near the south end of the Area of Review for Runway 1R-19L. The wetland boundary is confined to the extent of the ditchline. The boundary is distinct and follows the contour of the ditch that then extends southerly beyond the Area of Review. (Figure 6.3-1).
