PHASE I ENVIRONMENTAL SITE ASSESSMENT

Milwaukee Mitchell International Airport Runway 13-31 Removal

City of Milwaukee, Wisconsin – Milwaukee County

March 26, 2024

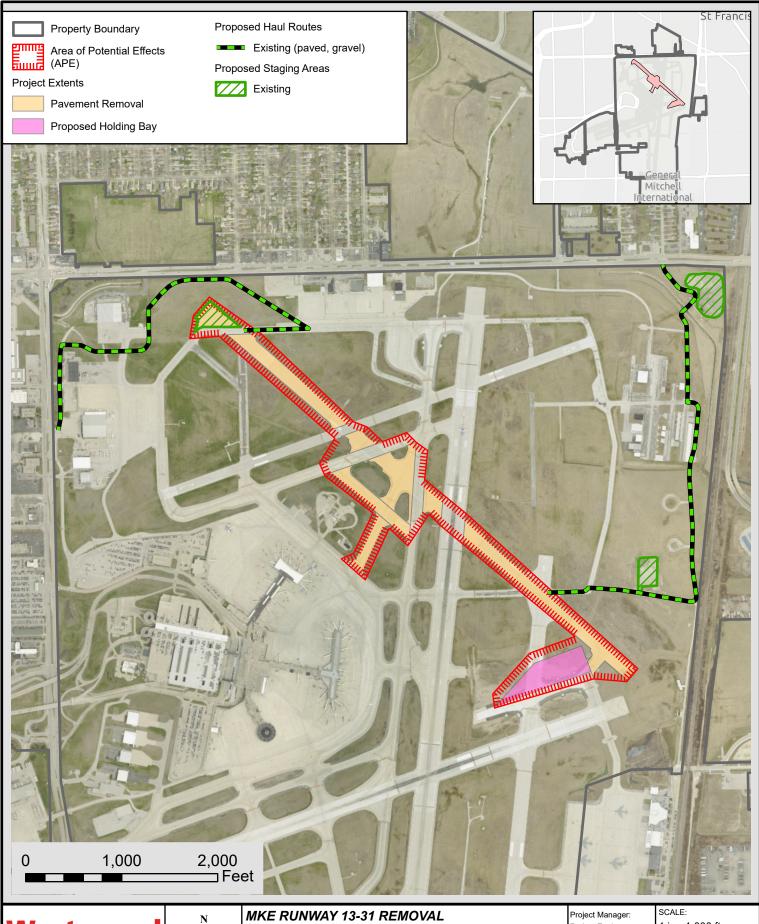
FIGURE NO. 2

The Subject Property is currently a part of the General Mitchell International Airport grounds. A runway was located on the Subject Property with the designation of 13 – 31. Runway pavement and utilities related to runway navigation (electrical) and stormwater were observed on the Subject

Property. Additional taxiway structures and electrical were observed south of the middle portion of the 13-31 runway. Other areas graded with green space were observed on either side of the runway (reference Figure 2 – Subject Property Site Map).

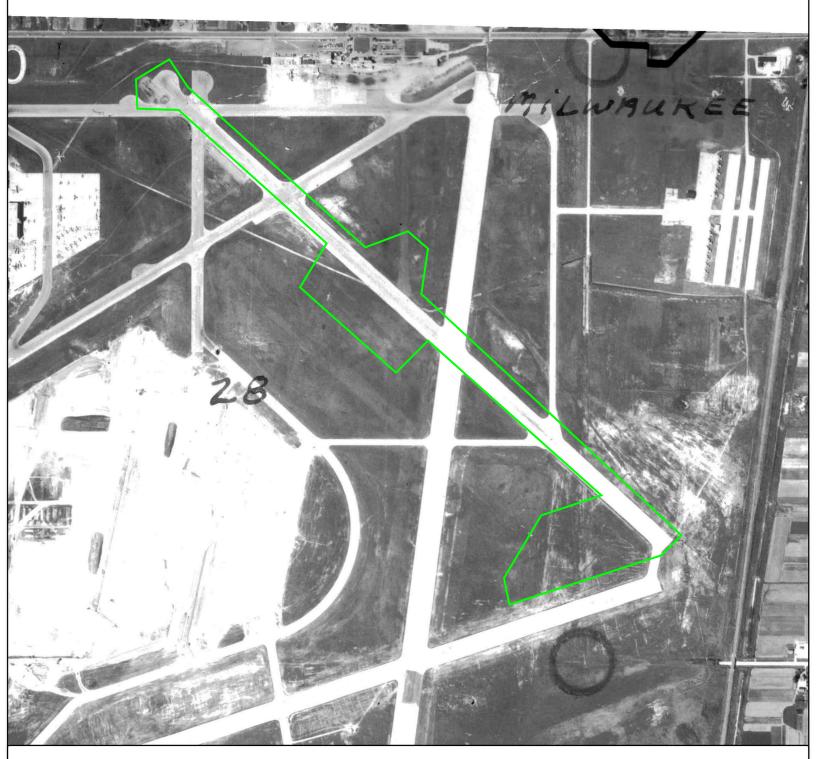
Year: 1950 Source: ASCS Address: Milwaukee Airport, Milwaukee, WI Approx Center: -87.89435516,42.95141584

The existing airport runway on the Subject Property appears to have been extended to the south by 1950. The remaining areas of the Subject Property appear relatively unchanged from the previous time period. Residential areas located on adjoining properties appear to have been razed and the western adjoining property appears to have additional disturbance due to construction. Additional airport runways were observed on adjoining properties, some of which intersect the existing runway on the Subject Property.

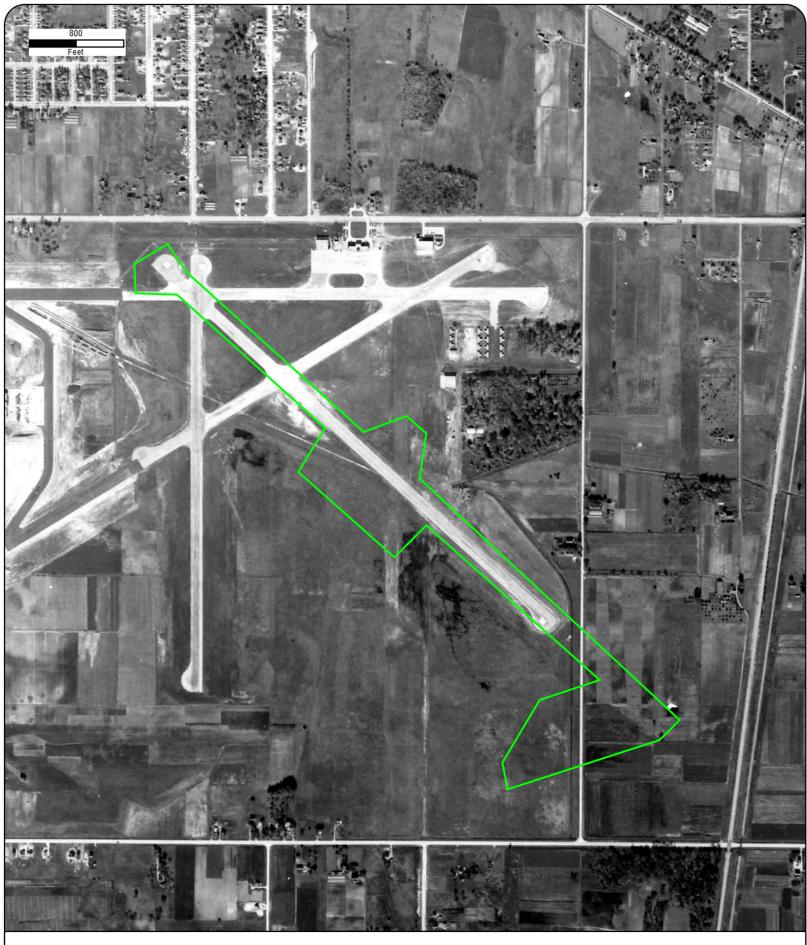
Year: 1941 Source: ASCS Scale: 1" = 800'

By 1941, the unpaved runway apparent on the Subject Property appears to have been paved and extended south to the area near the existing road on the southern portion of the Subject property. Additional airport runways were observed on the northern and western adjoining properties, and land disturbance to the west of the airport runways on the western adjoining property was observed due to possible construction. The remaining adjoining properties appear relatively unchanged from the previous time period.

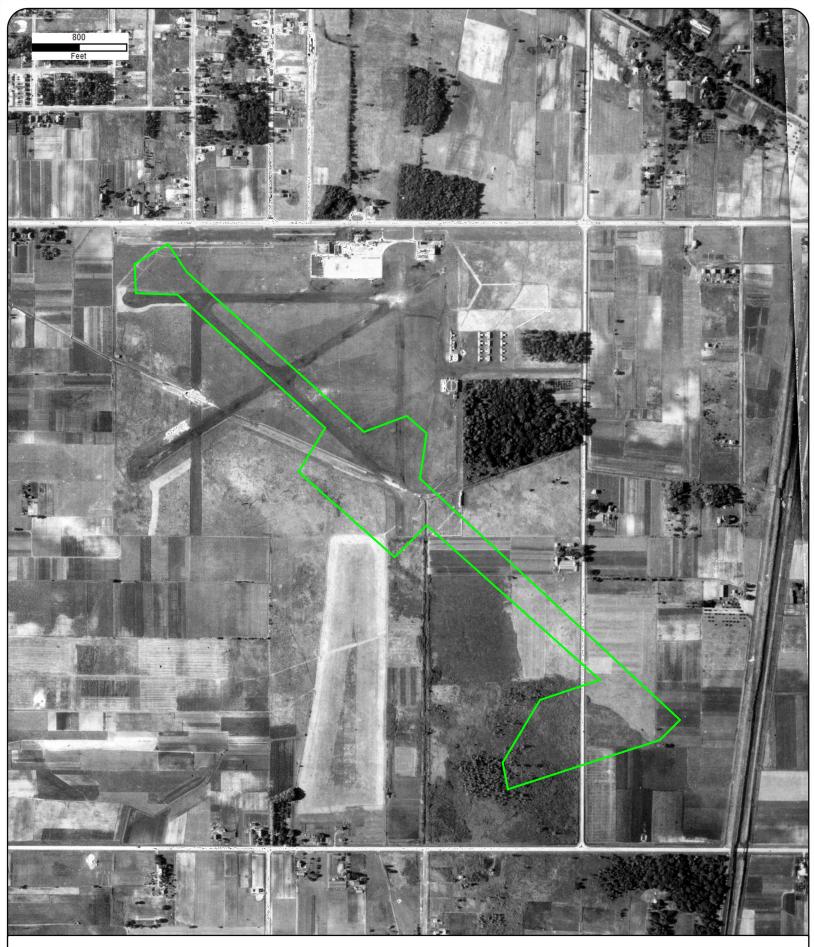
Year: 1937 Source: ASCS Scale: 1" = 800'

The Subject Property is pictured as agricultural fields with an apparent unpaved runway in the northern portion. An existing road was observed on the southern area of the Subject Property. Adjoining properties are pictured as agricultural fields with some areas of residential land, and apparent airport operations adjoining the northern portion of the Subject Property.
